BEST OF
2007
AWARDS

Yale University Art Gallery Kahn Building

AWARD OF MERIT: Rehab/Restoration/Renovation

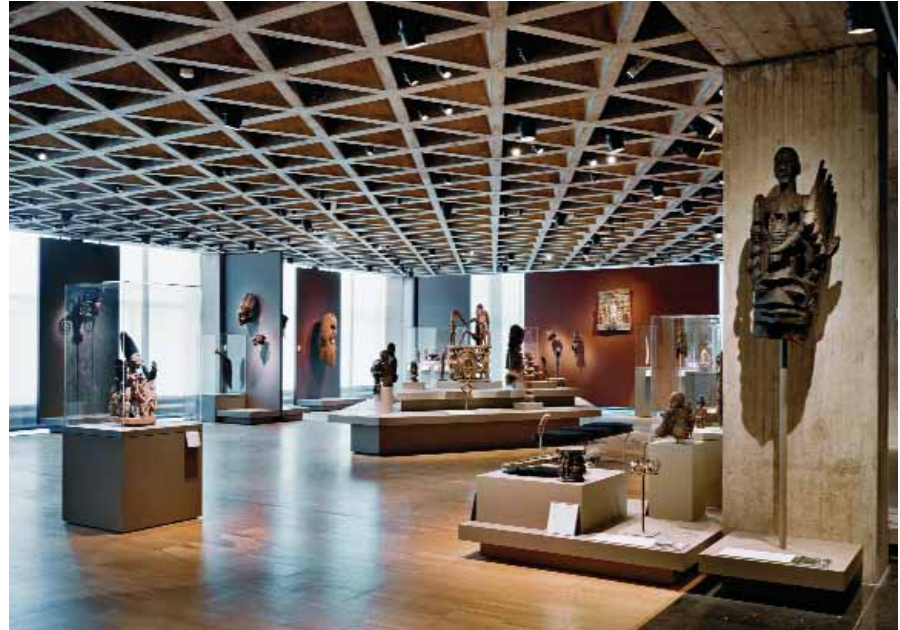
The new window-wall system employs thermally broken aluminum framing. Ex-

tensive frame customizations were required to match the original outside profile of the window wall. Interior dimension vary slightly to accommodate structural and wind loading requirements.

The distinctive steel and glass window wall, which graces the north and west facades, was one of the first uses of double-paned insulated glass. Considered innovative in its day, the system was plagued by structural and thermal problems.

Replicating the window-wall system using the same materials was impossible. The design team could not find a steel-framed system with thermal breaks, which dramatically slow heat loss and prevent condensation.
